FAILURE ANALYSIS AND LOCALIZATION OF CDM INDUCED MICRO DAMAGE IN HIGH SPEED I/O OF ADVANCED FINFET NODES

Caiyun Ren*, Jianfang Huang, Mian Rong

China Mobile phone department, Beijing X-Ring Technology Co., Ltd, Shanghai 201206, China

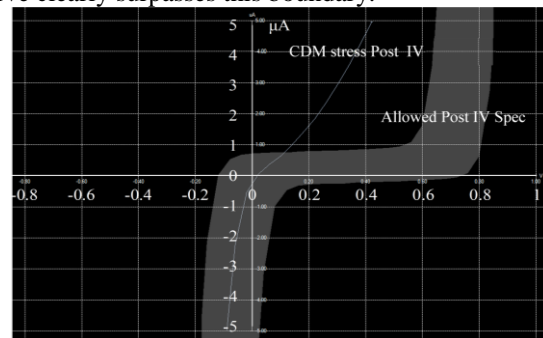
Figure 1: I-V Curve Manifestation for Chips Failed at CDM 250 V

Three chips were subjected to CDM stress at 250 V. Two devices exhibited significant I-V shift in their high-speed I/Os, exceeding the industry limit of $\pm 30\%$ within the $5 \mu\text{A}$ leakage boundary. As shown in Fig. 1, the white envelope represents the $\pm 30\%$ tolerance derived from the pre-stress I-V curve, while the post-stress IV curve clearly surpasses this boundary.

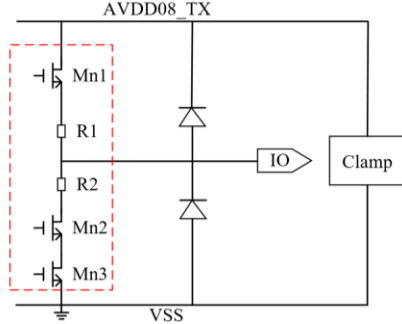
Figure 2: Simplified high-speed I/O schematic

characterization must traverse all possible paths. Verification showed a tenfold increase in leakage toward AVDD08_TX, along with a smaller rise toward AVDD12. Based on the I/O protection schematic (Fig. 2), where the ESD protection diode is directly connected to AVDD08_TX, this domain was identified as the dominant leakage path, guiding subsequent hot-spot localization.

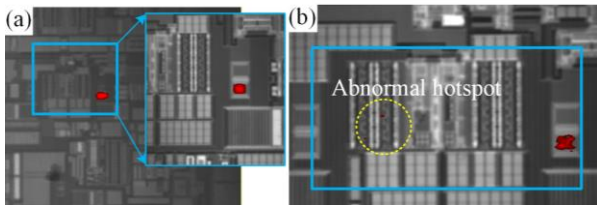
Optical Beam Induced Resistance Change (OBIRCH) was selected as the hot-spot localization technique. Bias was applied along the path from the I/O to AVDD08_TX during scanning. Both the reference and failed chips exhibited a hot-spot at the ESD diode, which is reasonable under a bias voltage of 0.8 V. However, the failed chip showed an additional hot spot in the I/O driver circuit (Fig. 3b), which was absent in the reference device (Fig. 3a). Layout correlation confirmed that this abnormal hot spot corresponds to the I/O driver circuit, specifically the region outlined by the red dashed box in Fig. 2.

Figure 3: (a) Hot-spot in the reference chip; (b) hot-spot in the failed chip. The failed chip exhibits an additional hot-spot in the I/O driver circuit.

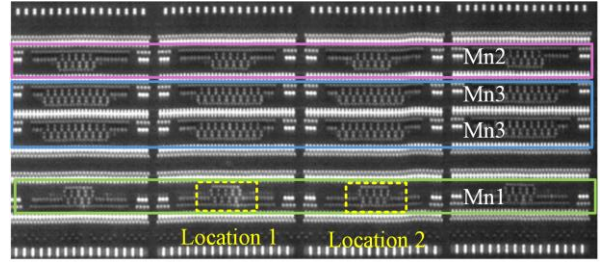
Figure 4. PVC revealing Mn1 anomaly

Failure localization narrowed the suspect region to the I/O driver circuit rather than the ESD protection diode. After delayering to the MD layer, the components in the I/O driver circuit became electrically isolated, preventing further refinement through global testing. Passive Voltage Contrast (PVC) was then used for precise localization. At 0.5 kV landing energy (Fig. 4), several Mn1 transistors exhibited distinct contrast; for example, the right vias at position 1 appeared bright, the left vias appeared dark, and all vias at position 2 were uniformly dark. Based on PVC principles, floating structures accumulate charge and appear dark, while grounded structures remain bright. These results suggest a leakage path from the gate to the substrate beneath the bright via at position 1.

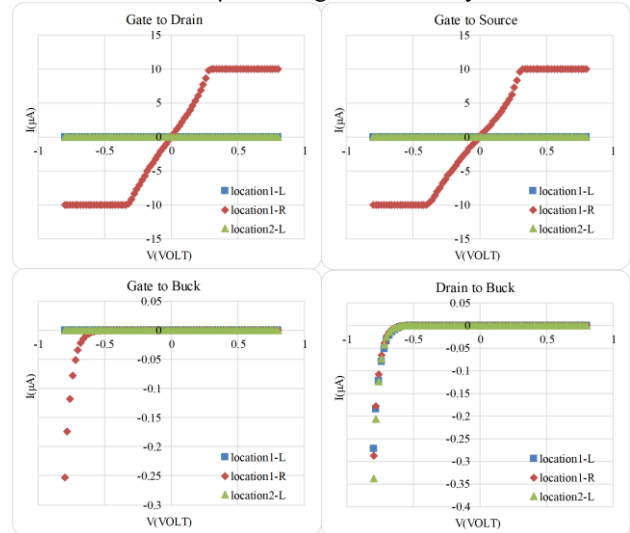
To confirm the defect, nanoprobe characterization was performed on devices at positions 1 and 2. Bias-scan results showed a significant reduction in gate-to-source/drain impedance on the right side of position 1 compared with its left side and position 2, indicating a localized conductive path in the gate oxide. To avoid secondary damage from DC stress, probe current was limited to $\pm 10 \mu\text{A}$ throughout the analysis.

Figure 5: Nanoprobe test results for positions 1 and 2. The left side of position 1 and position 2 exhibit normal impedance characteristics, leading to partial overlap of the data curves.

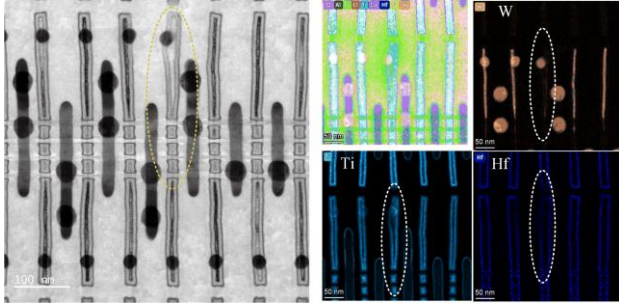
Figure 7: Planar TEM and EDS of position 1

A planar TEM section prepared for position 1 revealed gate breakdown on its right side (Fig. 7). EDS

analysis confirmed tungsten extrusion, fracture of the Ti-based barrier layer, and damage to the HfO₂ high-k dielectric. These findings align with the gate-oxide breakdown–melting model under CDM transient energy, identifying the failure mechanism as local melting damage induced by gate discharge.

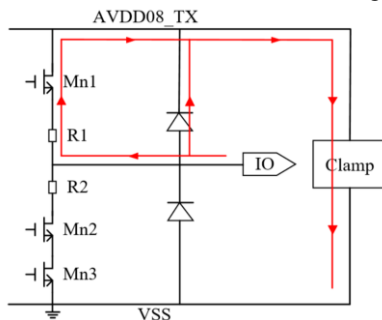
Figure 8: CDM stress current discharge path

Circuit analysis indicates that under a negative CDM pulse, the I/O node is driven to a high potential, and the discharge should ideally occur through the ESD protection diode. However, localization reveals that Mn1 fails first. Schematic analysis shows that a portion of the discharge current flows through Mn1, as illustrated in Fig. 8. Since Mn1's rated pulse current is significantly lower than the CDM peak current, this unintended path rapidly enters avalanche breakdown under high-density transient energy, resulting in localized thermal-electrical damage.

Increasing the device area is a feasible approach to improve CDM tolerance without significantly impacting circuit performance. Simulation results confirm that enlarging Mn1 does not degrade circuit performance. Therefore, this method offers both technical feasibility and practical engineering value.

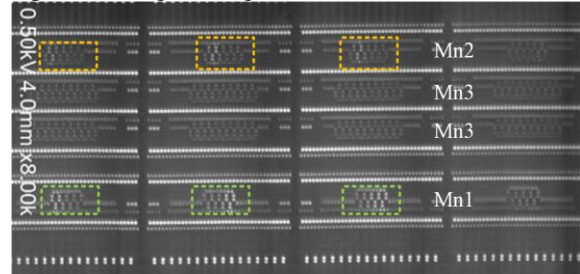
To validate the failure mechanism, another fresh sample was stressed at ± 500 V CDM. PVC analysis of this sample (Fig. 9) revealed that, in addition to Mn1, Mn2 also failed under this condition, indicating that the number of failed devices increases with stress voltage. Although Mn1 and Mn2 share identical device structures, their layout sizes differ. This observation suggests that Mn2,

with its larger area, can sustain a higher failure current and thus exhibits greater robustness.

Fig. 9. PVC image of the CDM-500 V failed chip, showing abnormalities in both the Mn2 and Mn1 regions.
